New York State Department of Transportation

Yellow Flag NB22CTW024

BIN: 1065318

Location: Span 183, Girder G1 at Pier 182

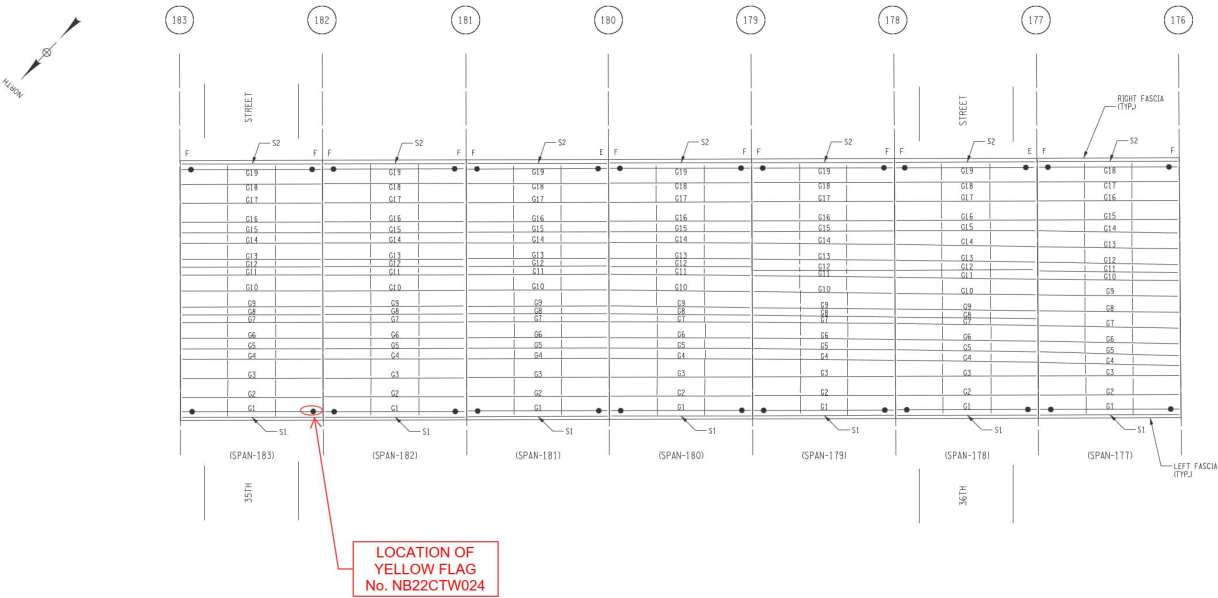
Photo Number: 1

Attachment Description: Framing Plan - Span 183

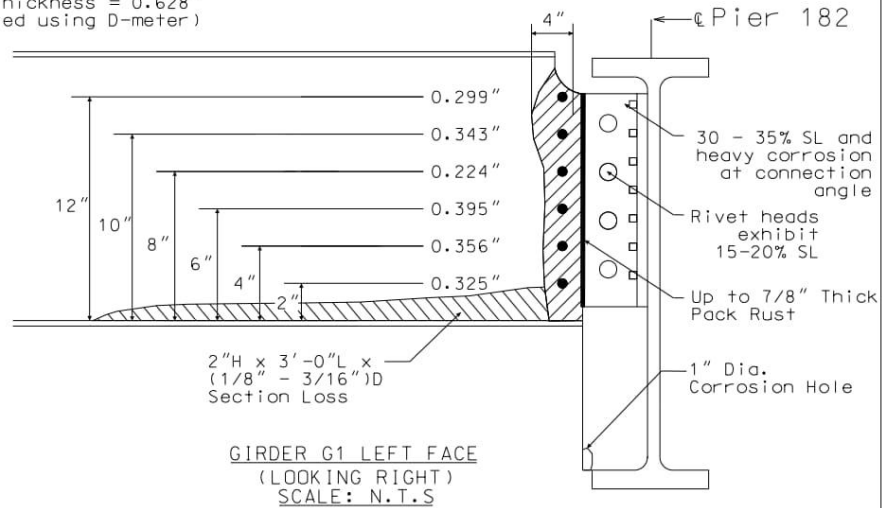
Photo Number: 2

Description: The end of Girder G1 web in Span 183 at Pier 182 exhibits overall 49% section loss for full height along the connection angle (see Sketch).

SHEARING WEB SECTION LOSS

$$\text{Average remaining web section} = \frac{(0.299 + 0.343 + 0.224 + 0.395 + 0.356 + 0.325)}{6} = 0.323 \text{ inches}$$

$$\text{Web section loss} = [1 - (\frac{0.323}{0.628})] \times 100\% = 48.56\% \text{ SAY } 49\%$$

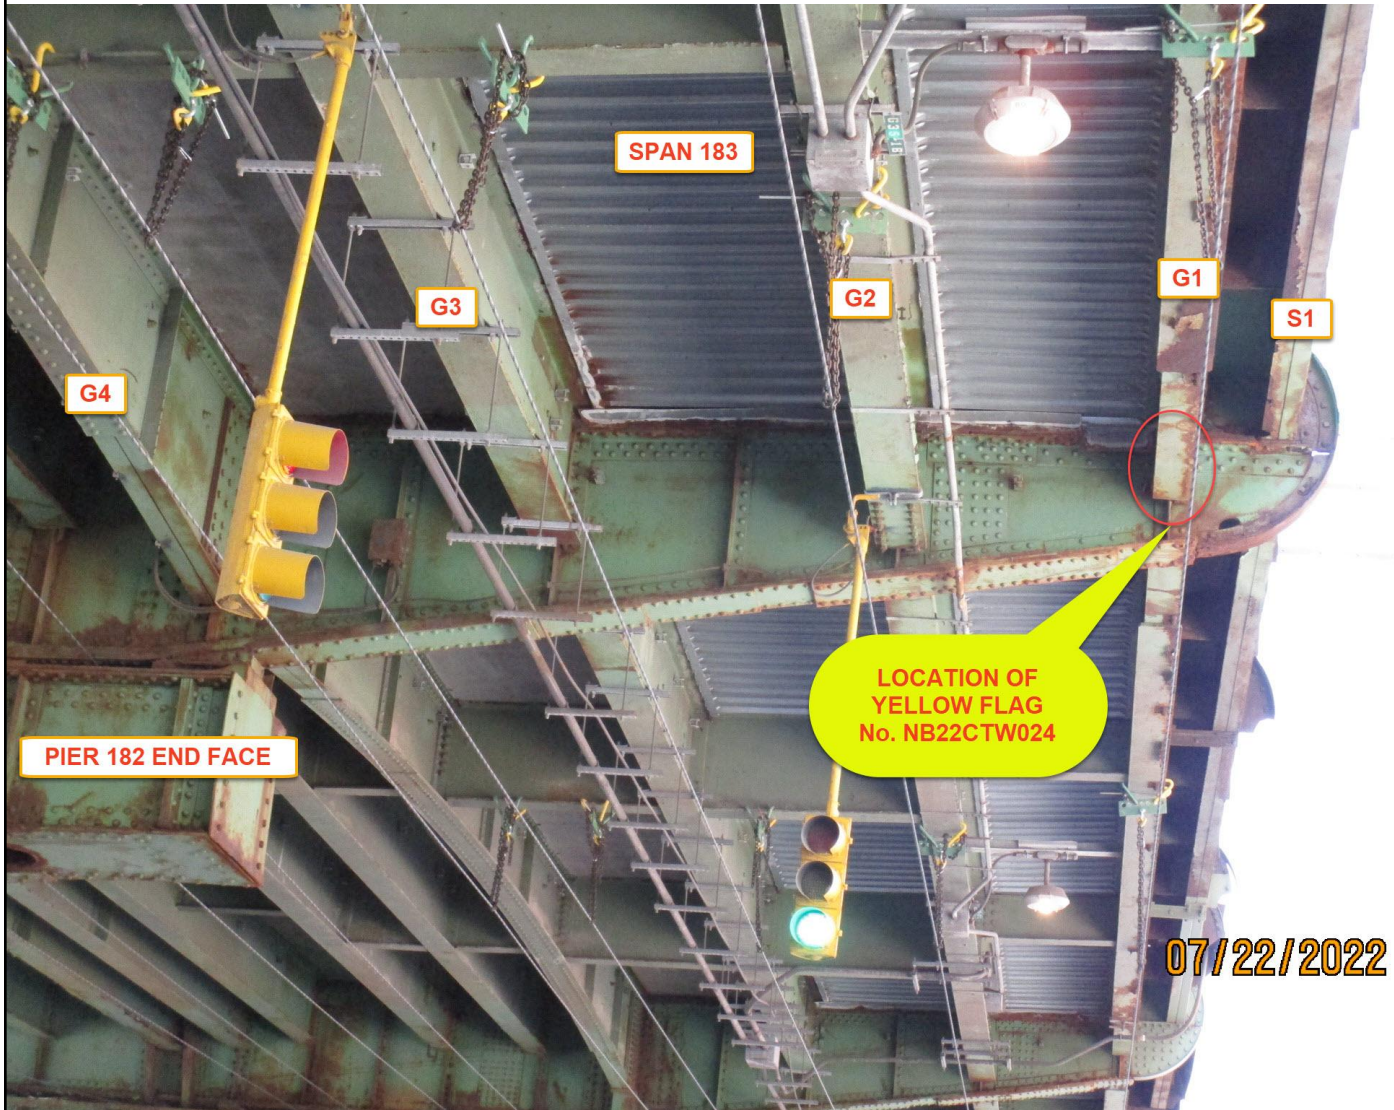
Photo Number: 3

Attachment Description: General view of the flagged condition at Span 183 Girder G1 at Pier 182. Looking Begin.

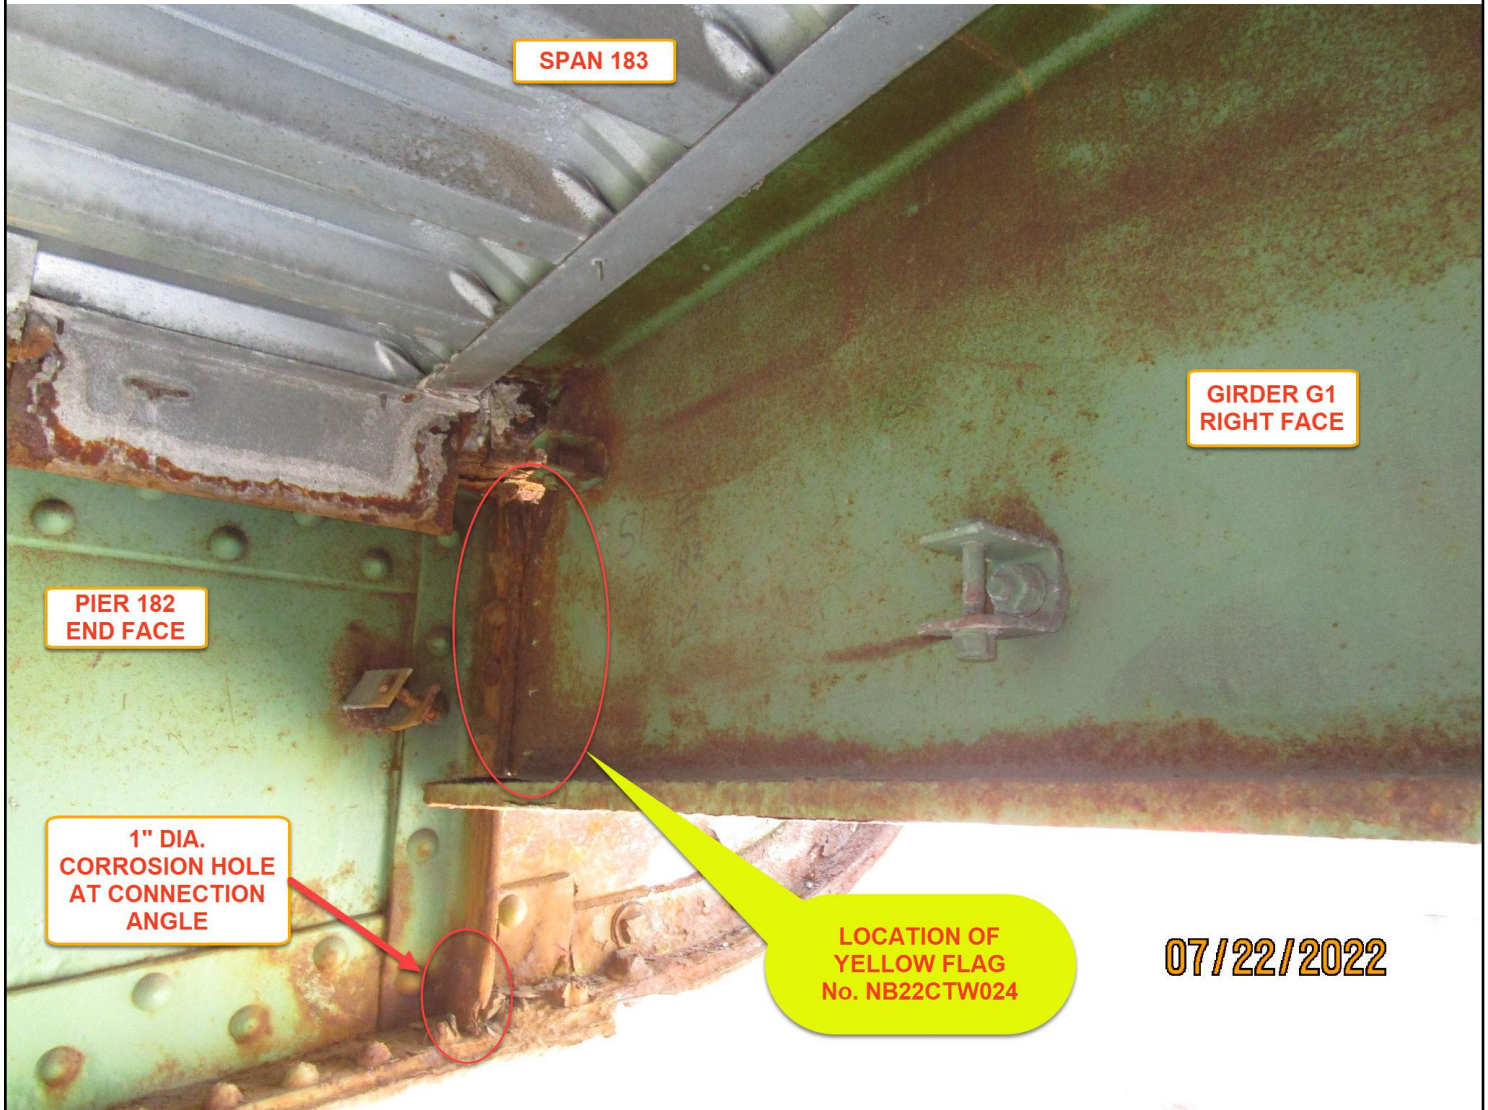
Photo Number: 4

Attachment Description: Close up general view of the flagged condition at Span 183 Girder G1 at Pier 182. Looking Begin Left.

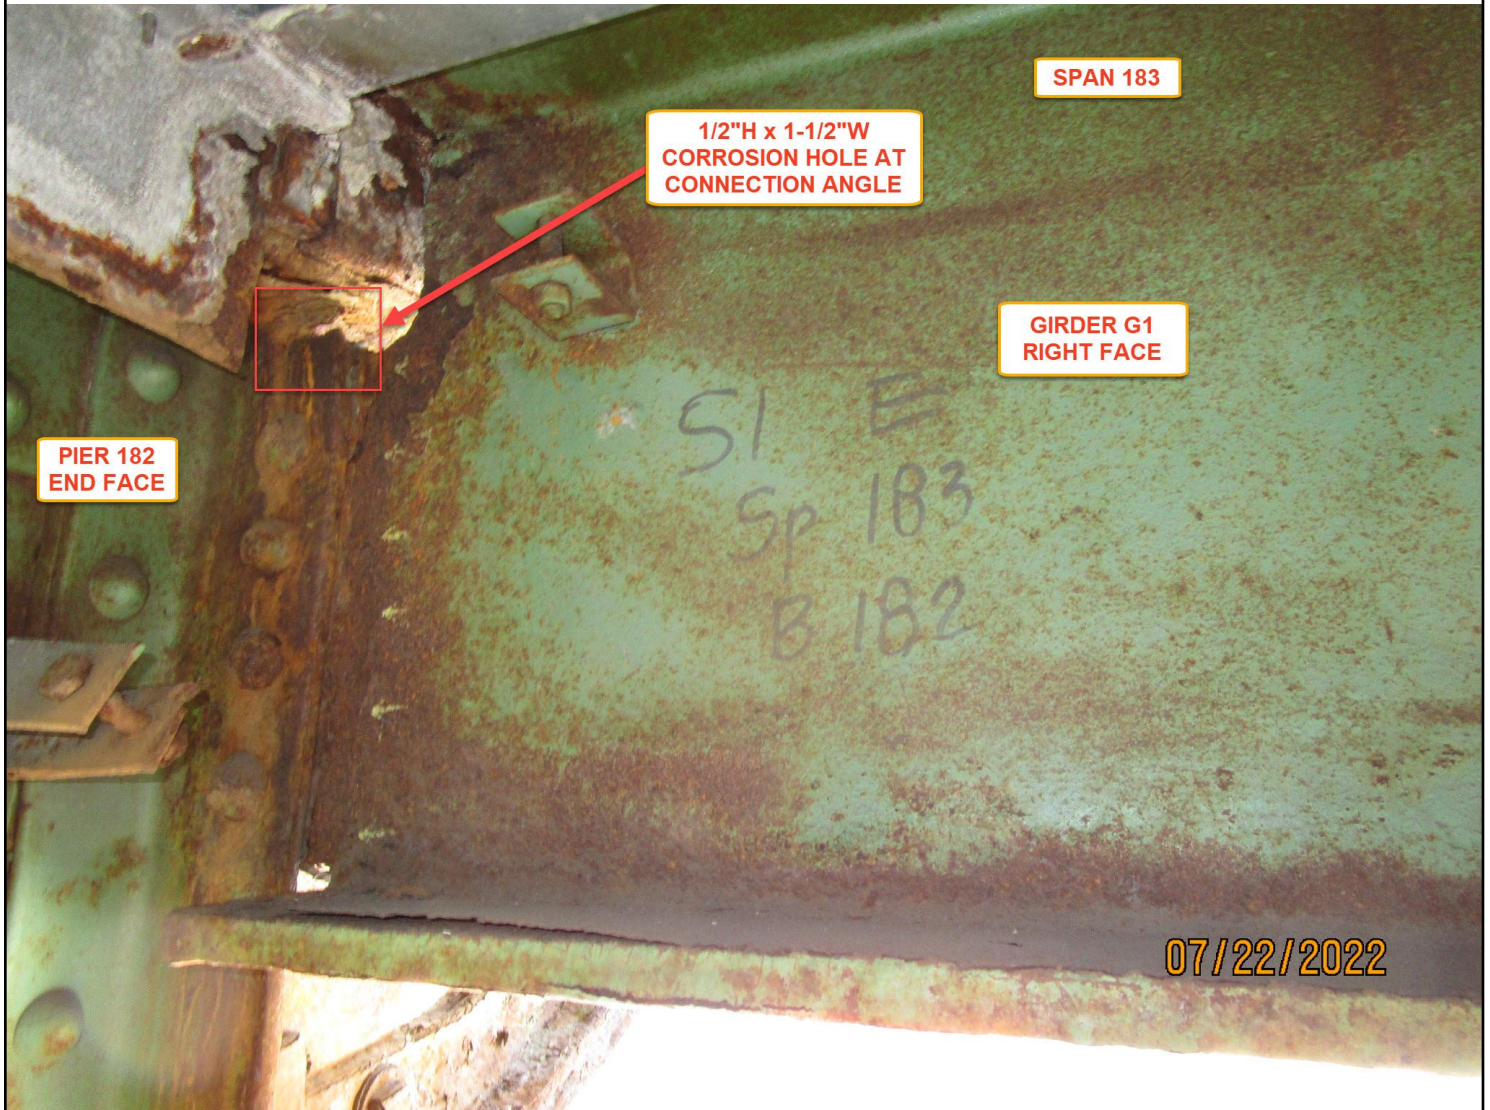
Photo Number: 5

Additionally, the lower web of the left side of the girder at the pier exhibits a 2" high x 3'-0" long area with 1/8" to 3/16" deep section loss and the left side connection angle exhibits up to 7/8" thick pack rust for full height, heavy corrosion with 30 to 35% section loss throughout, and 15 to 20% section loss at rivet heads. The right side connection angle exhibits up to 1/8" thick pack rust at the top 3 inches with two (2) corrosion holes, 1/2" high x 1-1/2" wide at the top and a 1" dia. corrosion hole at the bottom (see Photo 5 and Sketch).

Attachment Description: The right side connection angle exhibits up to 1/8" thick pack rust at the top 3 inches with a 1/2" high x 1-1/2" wide corrosion hole at the top. Looking Begin Left.

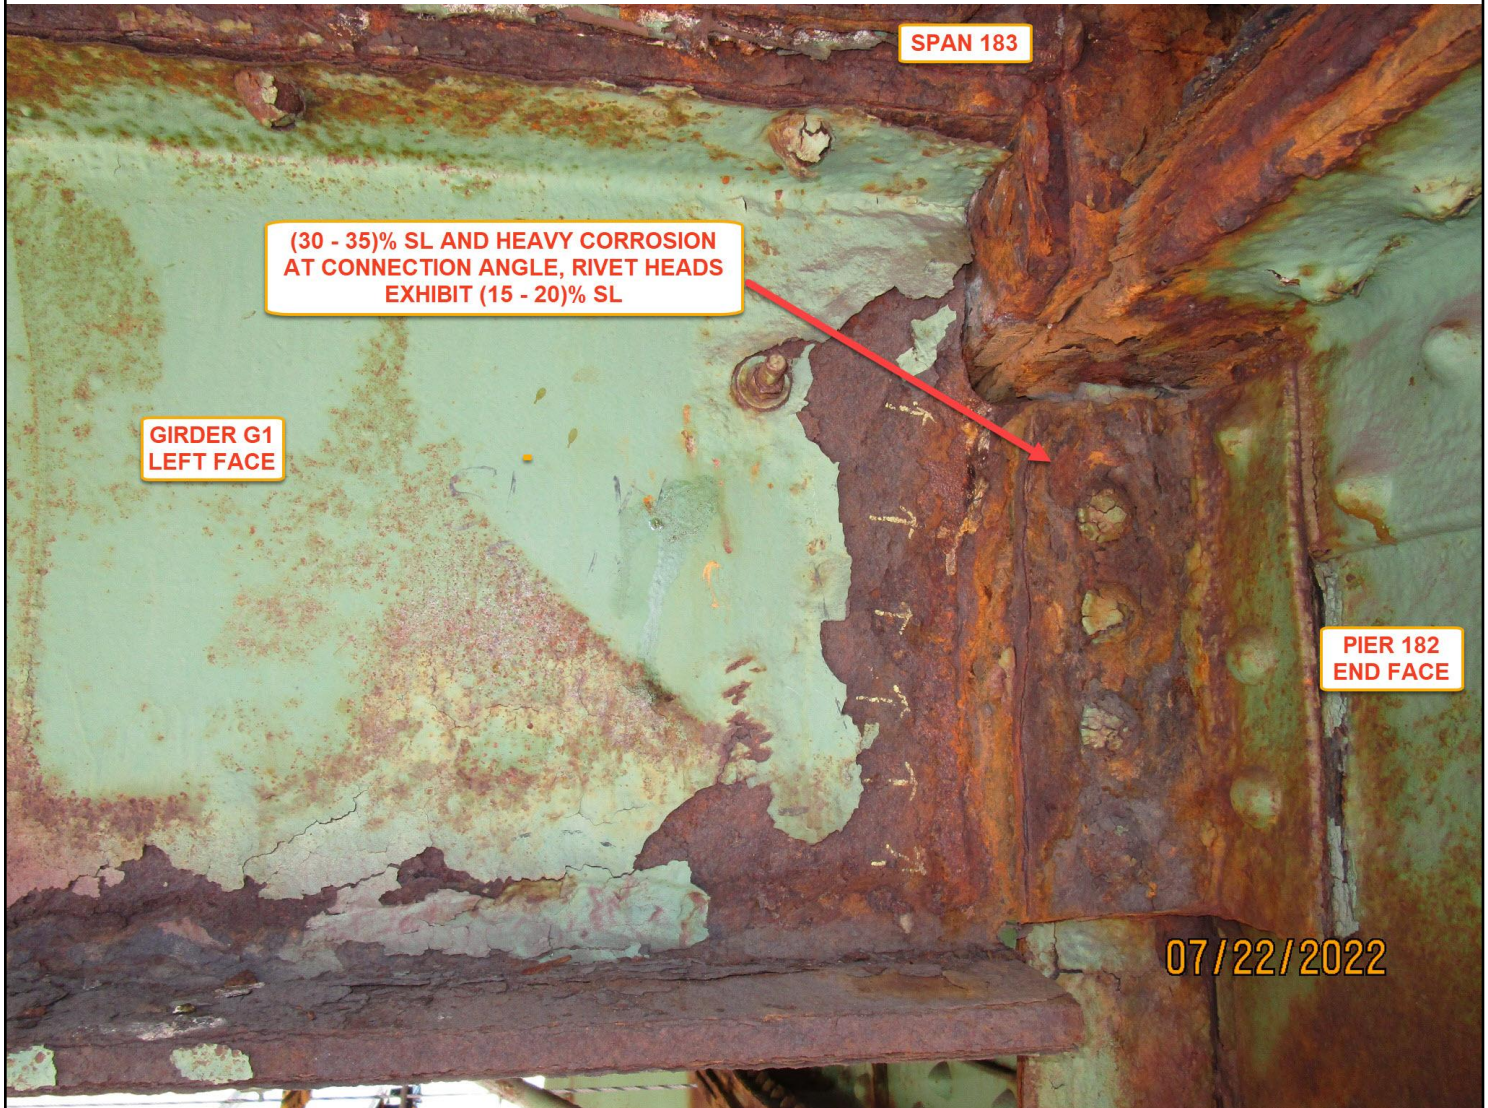
Photo Number: 6

Attachment Description: The left side of Girder G1 web exhibits a 4" wide x full height area with heavy corrosion along the connection angle. D-meter readings indicate up to 49% section loss. The lower web exhibits a 2" high x 3'-0" long area with 1/8" to 3/16" deep section loss. Looking Begin Right.
